EGYPTIAN-ITALIAN
ENVIRONMENTAL COOPERATION PROGRAM
PHASE II

HAND-OVER CERTIFICATE

Wadi el Rayan Protected Area Project

Visitor Center of Wadi Rayan Protected Area **Maintenance plan**

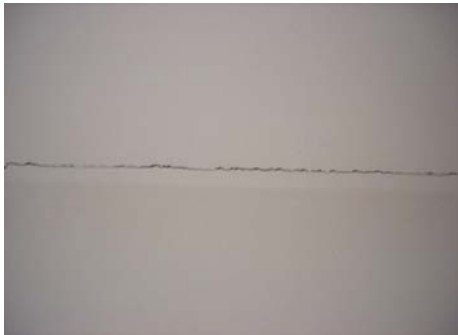
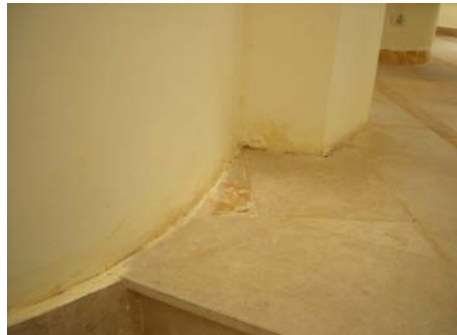
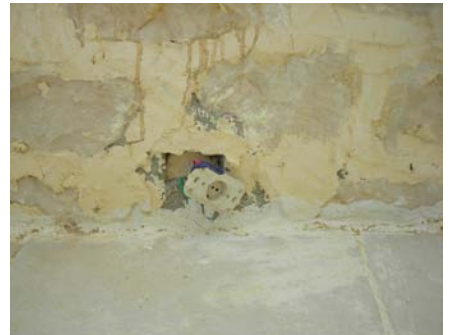
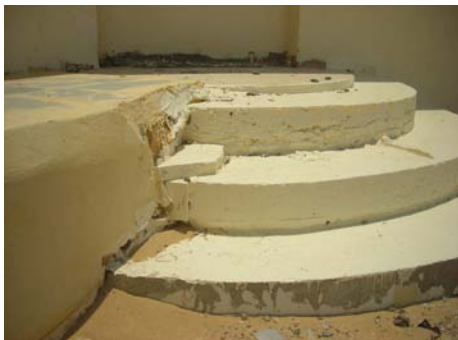
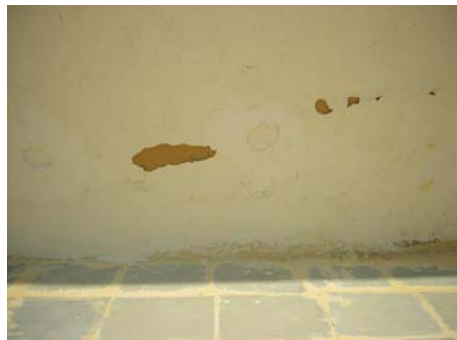
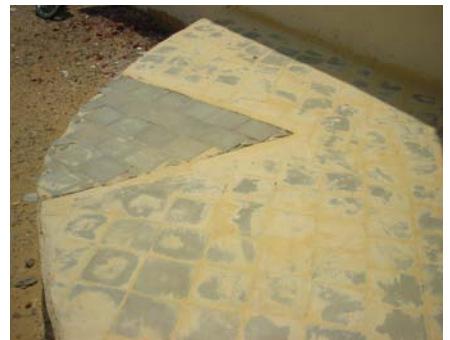
- **Decay:** even if renovated works have been recently provided (2009), degradation phenomena affect the building, especially in finishes. Main detected disease are reported as follow:
 - cracks in the inner and outdoor plaster and in the floor;
 - detachments and lacks in the outdoor and inner plaster;
 - bad execution of flooring' laying with inserts of extraneous material,
 - some power line' wires are exposed and some sockets are unsafe.

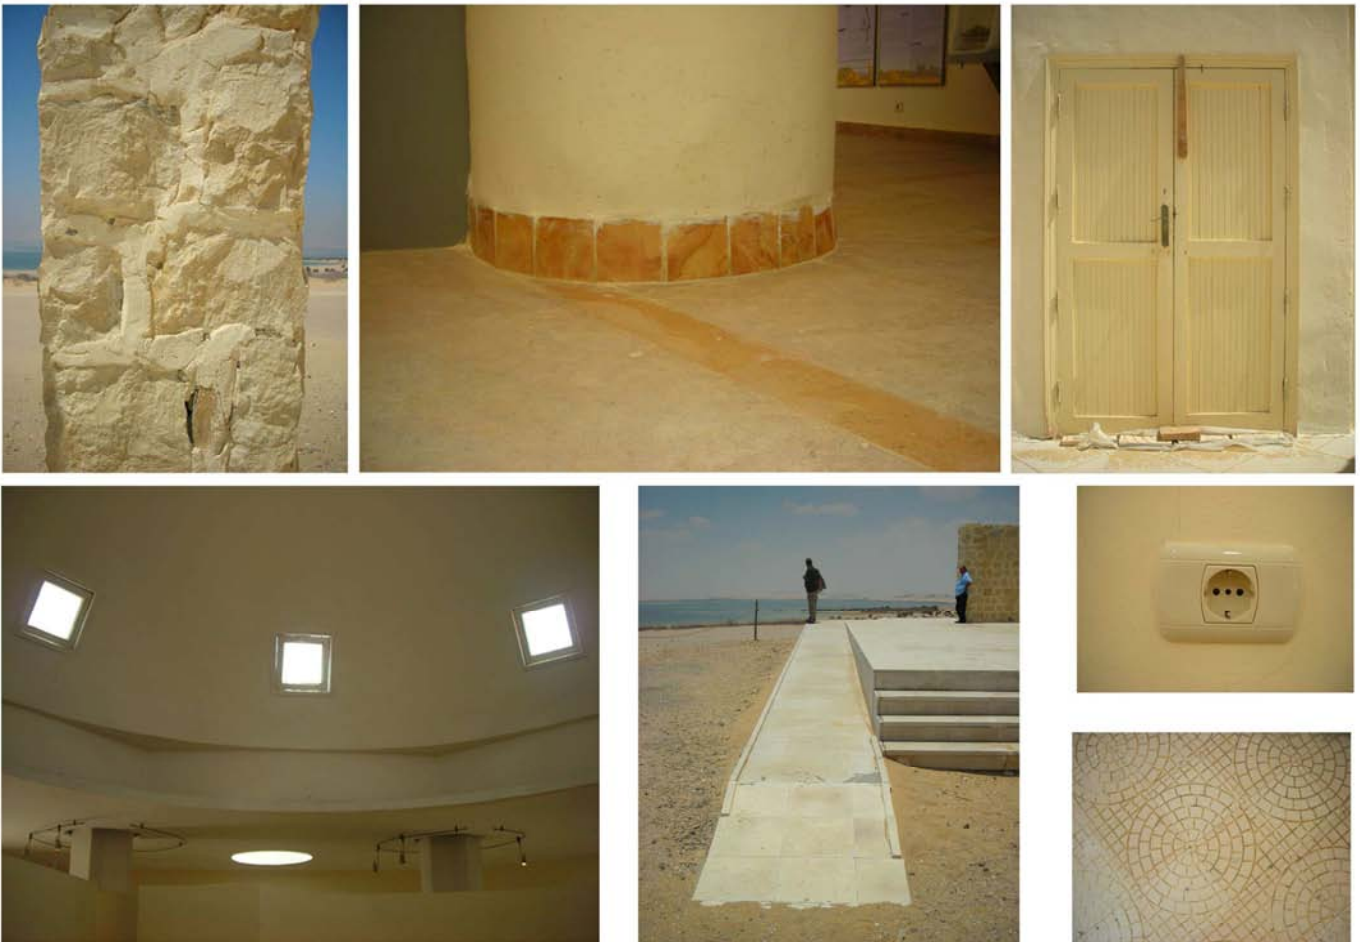
Photographic survey: details

1. Stone wall; 2. Inner marble flooring and baseboard; 3. Wooden door;
4. Dome skylights; 5. Slip road; 6. Socket; 7. Outdoor floor

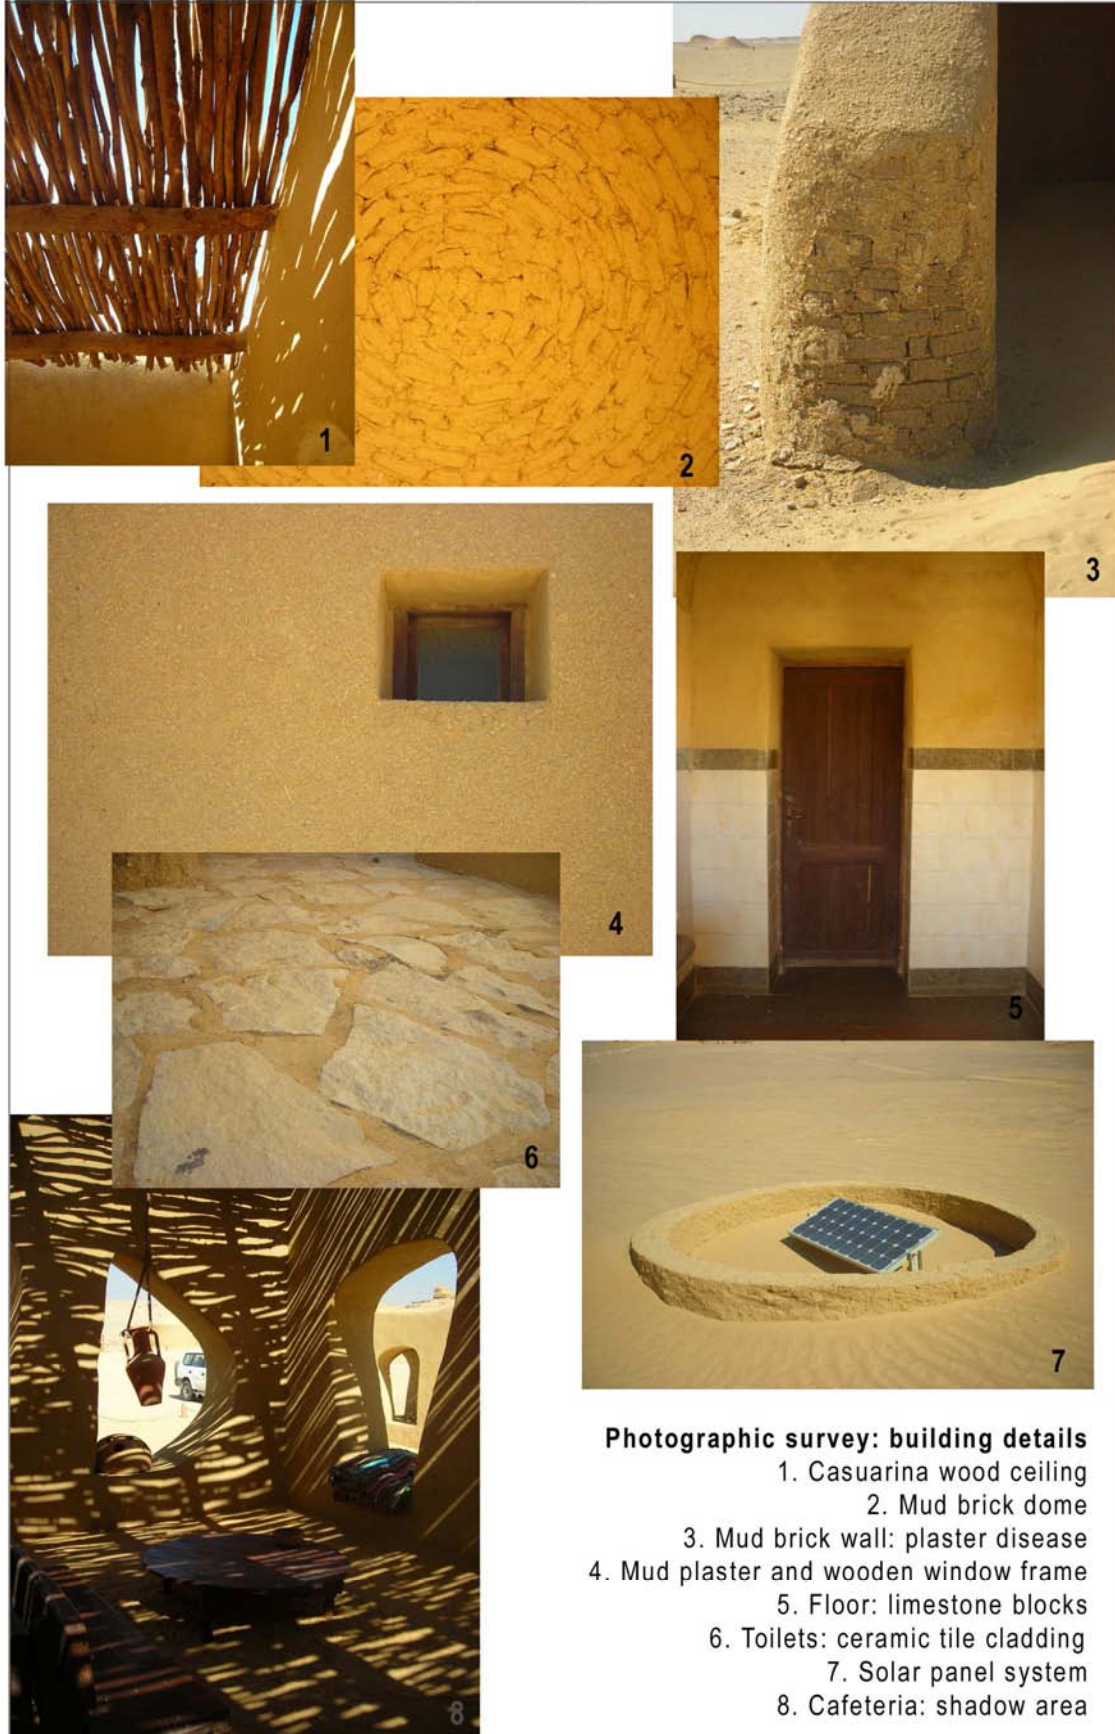
WADI HITAN_VISITOR CENTER_details_

1. Casuarina wood ceiling
2. Mud brick dome
3. Mud brick wall: plaster disease
4. Mud plaster and wooden window frame
5. Floor: limestone blocks
6. Toilets: ceramic tile cladding
7. Solar panel system
8. Cafeteria: shadow area

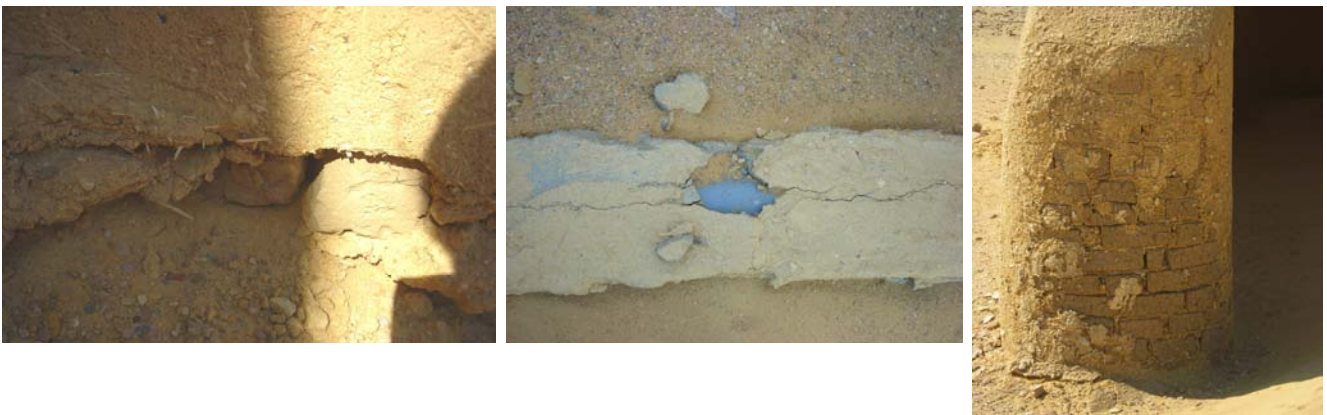
Main diseases detected are:

- cracks and chips in the mud plaster
- lack of mud plaster
- deficiency of system protection

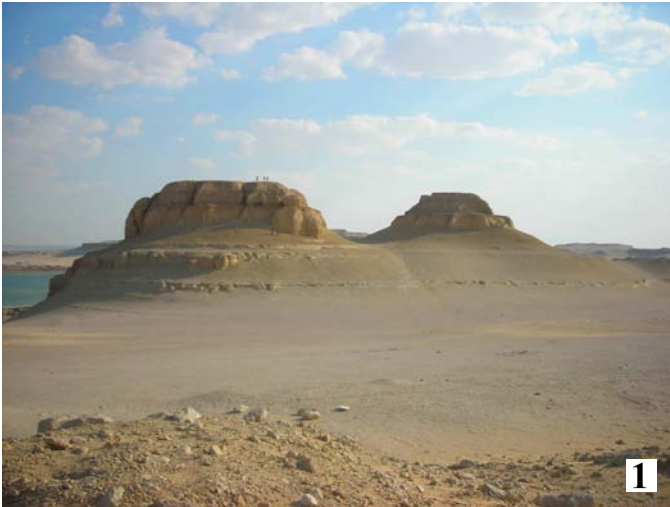
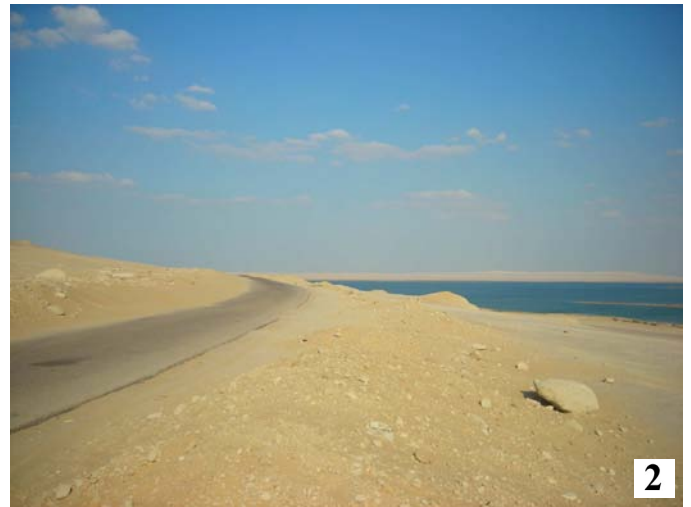
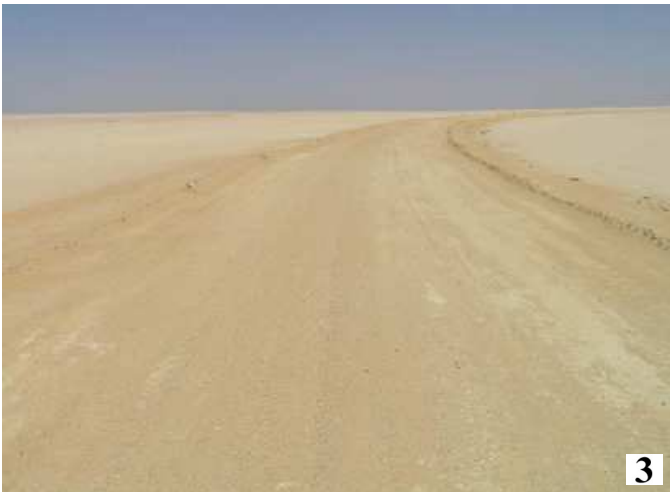
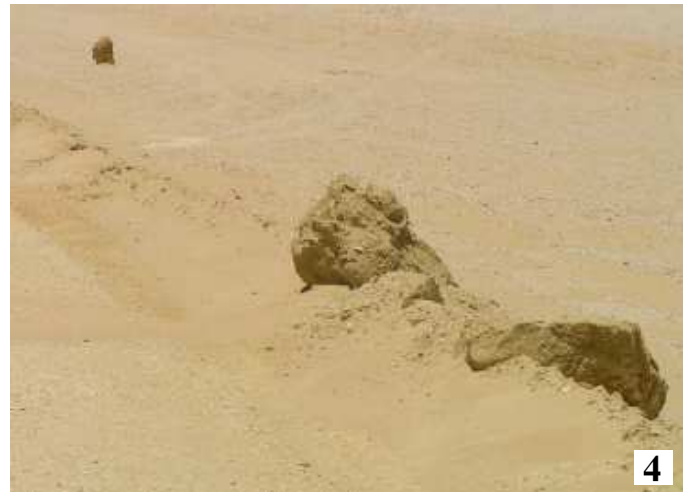
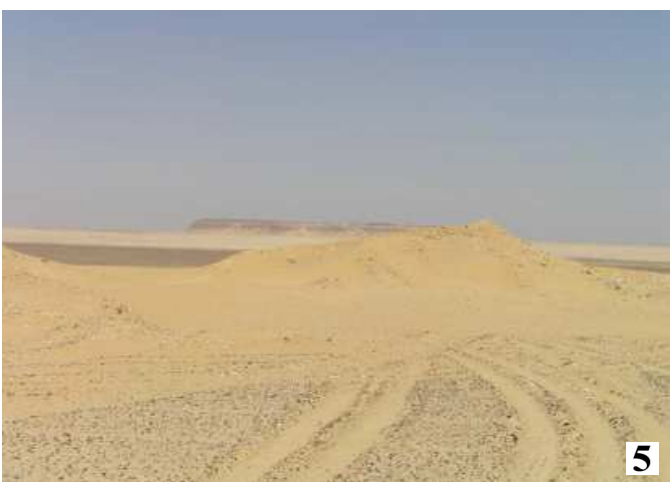
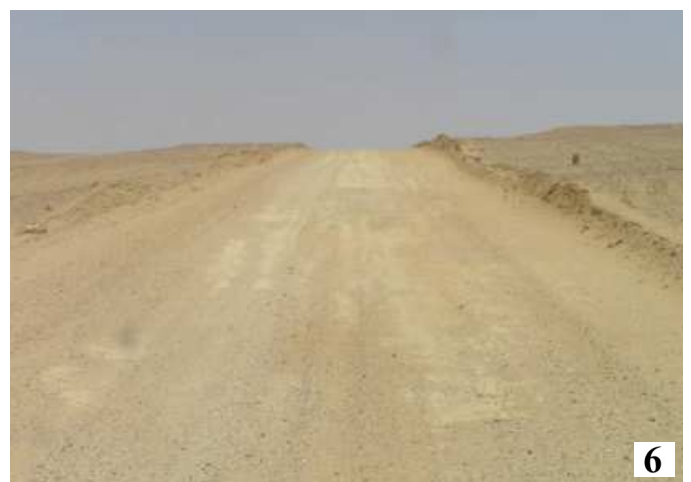
1.4 Photographic survey

- 1. Gebel el mudawara
- 2. Asphalt road
- 3. Unpaved track
- 4. Track borders
- 5. Sand removal
- 6. Unpaved track
